PROPERTY INSPECTION REPORT

ADVANCED HOME INSPECTIONS

Subject property,
123 Pine St.
Any Town, CA

FILE #:	120101
DATE OF INSPECTION:	1/2/12
TIME OF INSPECTION:	Start: 9am. Finish: 1pm.
CLIENT/S:	John Samples
INSPECTION SITE:	123 Pine St. Any Town, CA

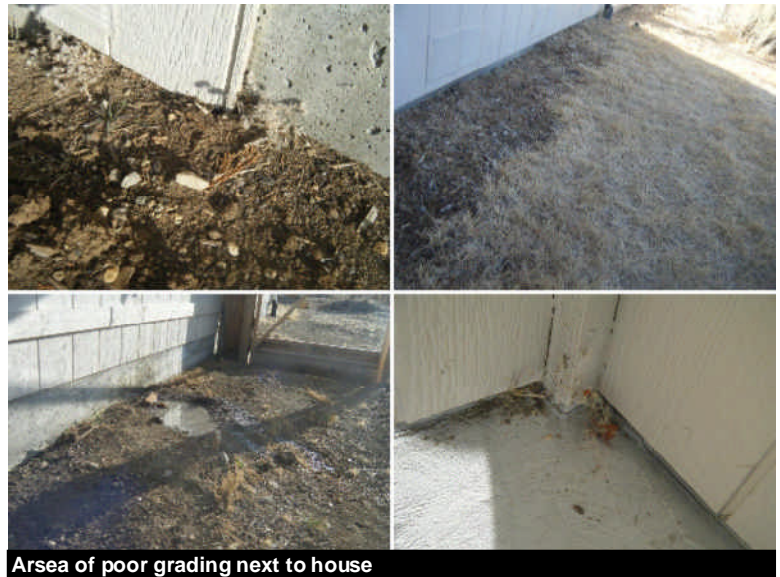
Arsea of poor grading next to house

Gentle sloped site. *Grade at foundation needs correction at some areas. Soil is high at foundation and in contact with the siding. Soil slopes towards foundation at some areas. Wood debris in contact with soil noted around the house.

The building wall may be subject to damage if components are in contact with the soil. Water leakage into the building may be experienced if the soil is above top of the foundation wall. The increased load exerted on the foundation can push the foundation walls inward, particularly in areas where frozen soil conditions may exist.

Recommend lowering soil below siding, eliminate earth-to-wood contact and pitch slope of soils away from foundation. Ideally, the grade should be 6 inches below any wood materials and grade should fall away from the foundation at a minimum of 1/2 inch per foot and extend at least 10 feet away from the foundation.

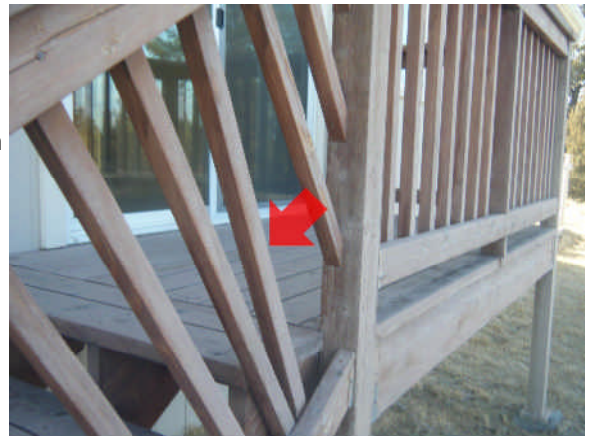
The deck appears serviceable. Steps appear serviceable. *Handrails / Guardrails are loose at steps. Balusters are loose / damaged. *Paint / finish or waterproofing is recommended to the wood deck, steps and railings.

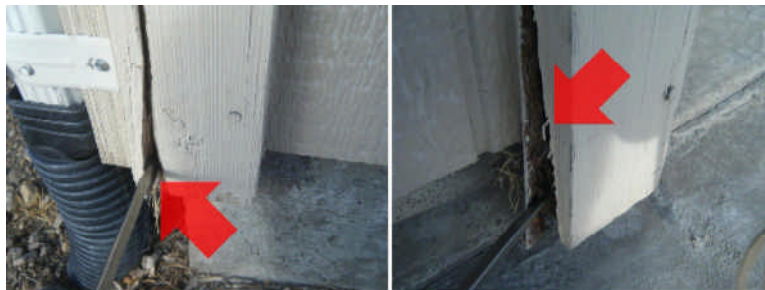
The exterior trim appears serviceable with the following exceptions noted below. *Typical cracks and separations noted at some areas. Caulk / sealant is recommended.

(3) (2) Damage/ wood rot noted to corner trim, front S.E corner of house and garage vehicle door trim.

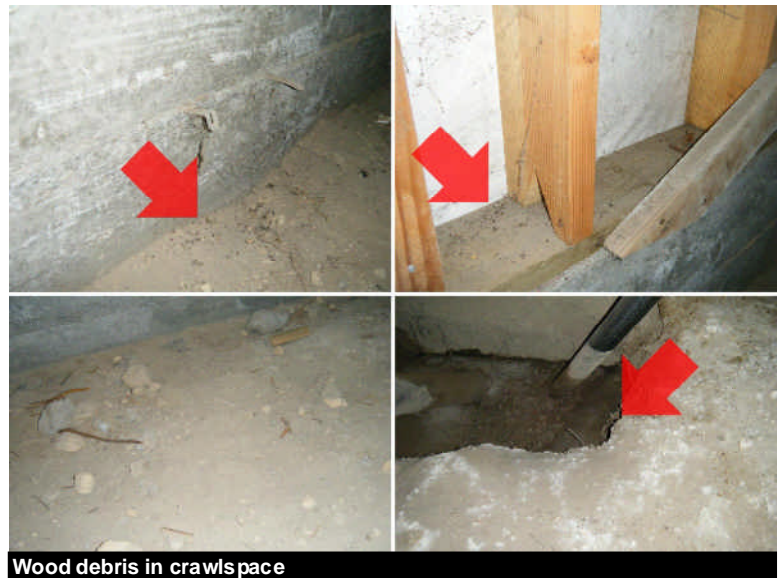
Wood debris in crawlspace

(3) Signs of prior ant activity noted in the crawlspace, top photos. Refer to the pest report.

*Dug out area in crawlspace at plumbing piping entry, bottom right photo. Moisture noted at hole.

Vents are provided. Moisture barrier is not installed. Floor insulation is provided. No moisture present. *Recommend removing wood debris from the crawl space area, bottom left photo.

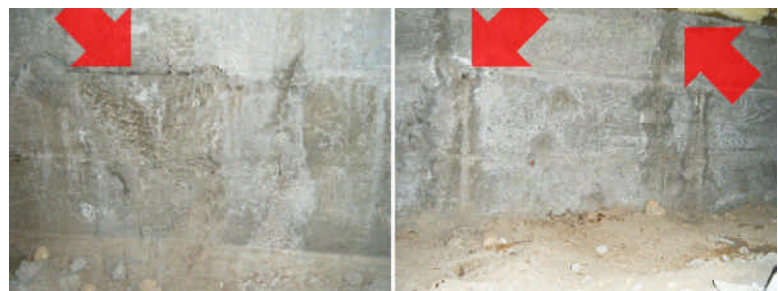
*Pockets / holes noted in foundation in crawlspace. Evidence of prior water penetration noted.

Water seepage may recur in the future. The best defense against water seepage is good drainage of soils near the foundation wall. Recommend sealing cracks / holes with approved concrete sealant.

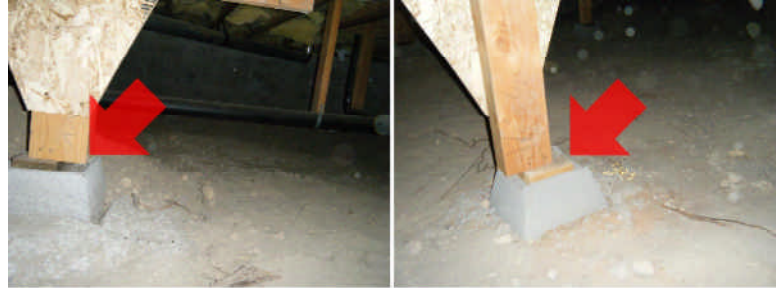
Posts / columns are wood. Piers are concrete.
*Some posts are poorly bearing on piers.

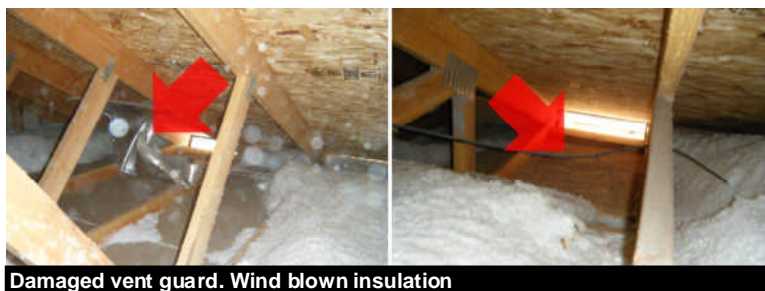
Damaged vent guard. Wind blown insulation

*Vent guards in attic are damaged. Insulation has been moved by wind, poor coverage noted at some areas.

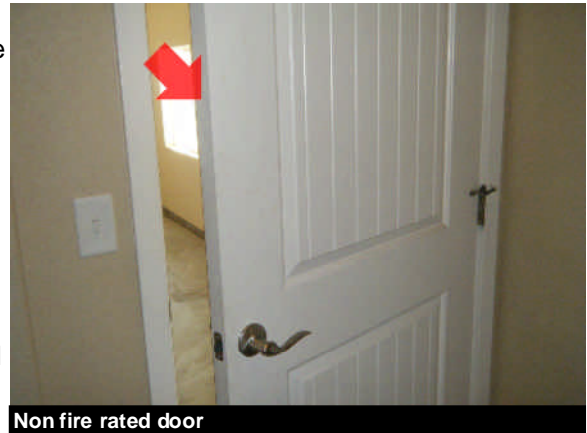
Walls and ceiling appear to be fire rated. *Unable to determine if passage door is fire rated. Self closer is installed on door. Self closer needs adjustment. Recommend repairing small hole in garage wall.

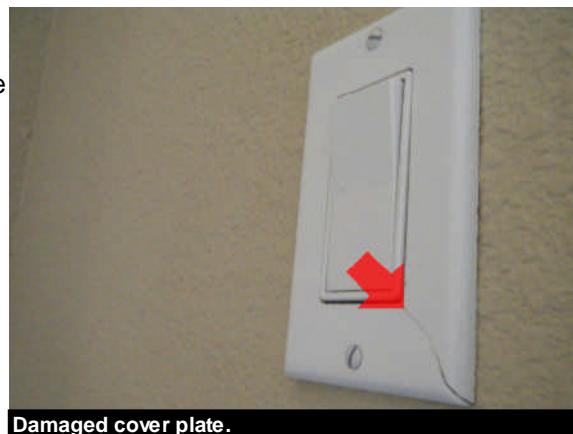
All outlets, switches, and lights were tested. Outlets, switches and lights throughout the house are in serviceable condition. GFCI outlets respond to test. Ceiling fans are operational. Door bell works.
*Damaged cover plate at switch in livingroom. *Light fixture cover/s loose/damaged at kitchen ceiling.

Damaged cover plate.

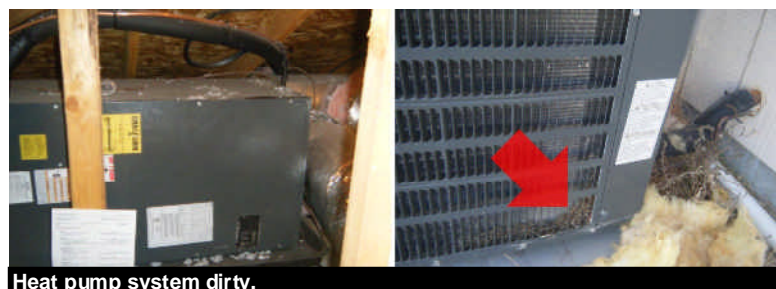
Heat pump system dirty.

(2) Heat pump system does not appear to have been serviced within the past two years. Suggest cleaning/servicing entire system including duct system. Contact a licensed heating / cooling contractor.

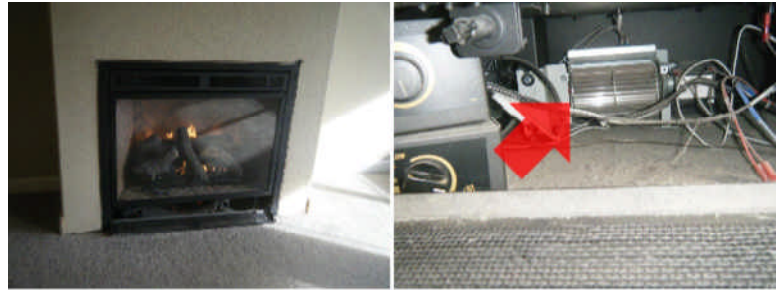
Gas log burning fireplace located in livingroom.

(2) The blower in unit is non functional. Controls, wiring and fan compartment is dirty / dusty;

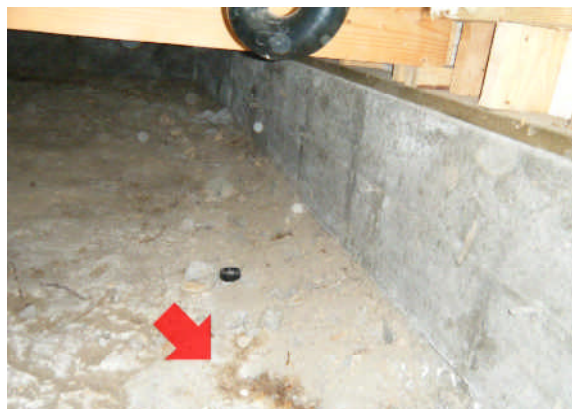
*Signs of prior leaking at bathtub drain pipe in crawlspace. No active leaks found.

Signs of prior leaks in crawlspace.

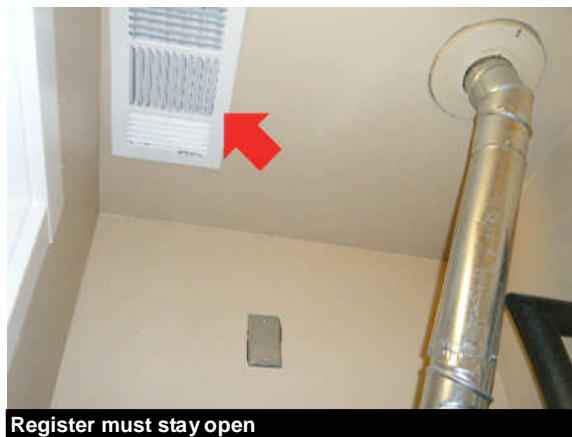
*Fresh air vent at enclosure ceiling is closed. Register is not for forced air heater, fresh air vent only. Recommend keeping register in open position .

Register must stay open

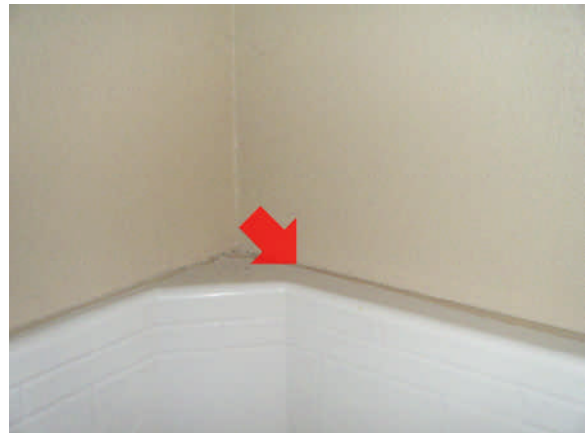
TUB/SHOWER AND WALLS, CEILINGS AND FLOORS: Tub and shower areas appear serviceable. Enclosure appears serviceable. *Cracks noted at top of shower enclosure. Caulk and seal all tub and shower areas as a precaution.

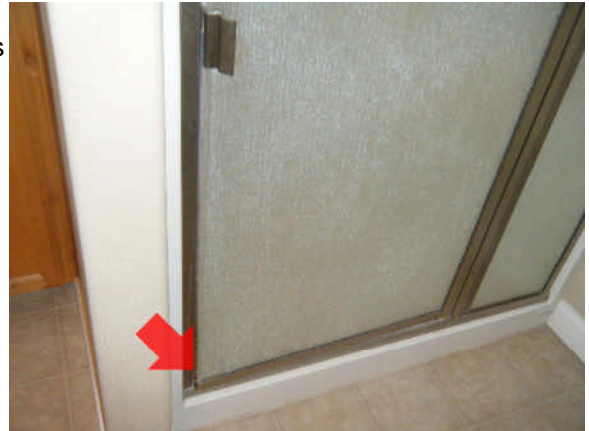
Tub and shower areas appear serviceable. Enclosure appears serviceable. *Shower door does not properly close / latch.

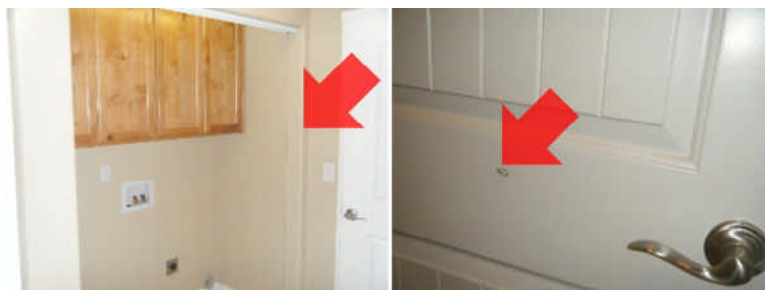
*Missing doors noted at laundry area. Minor damage to door at water heater enclosure.

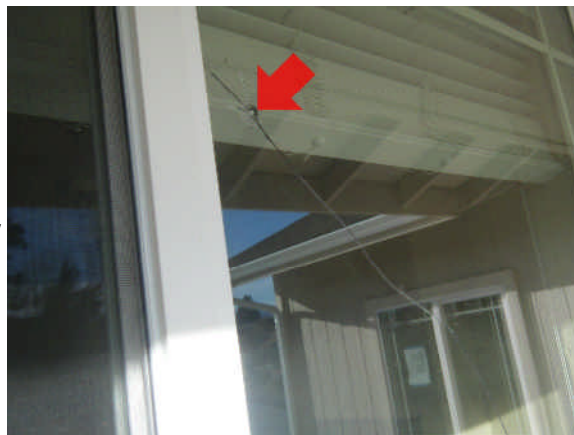
*Some windows do not close properly / do not fit square in frames, or frames are buckled / warped.

(4) (2), Broken / cracked glass noted at livingroom. Contact glass / window company.

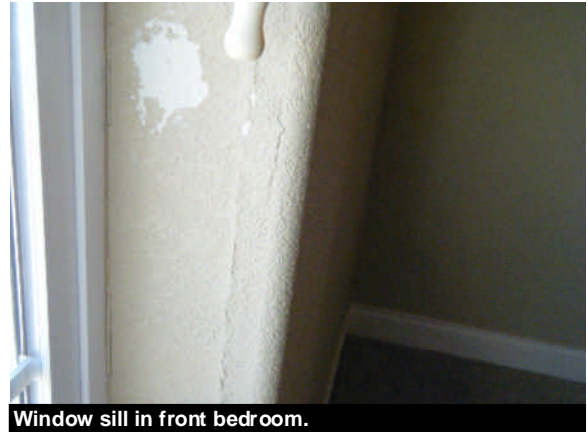
Interior wall materials are drywall. General condition appears serviceable. Typical cracks noted at various areas.
*Signs of prior water entry at window frame / sill and wall in front bedroom, possibly due to window not closing properly or fitting properly into frame.

Window sill in front bedroom.

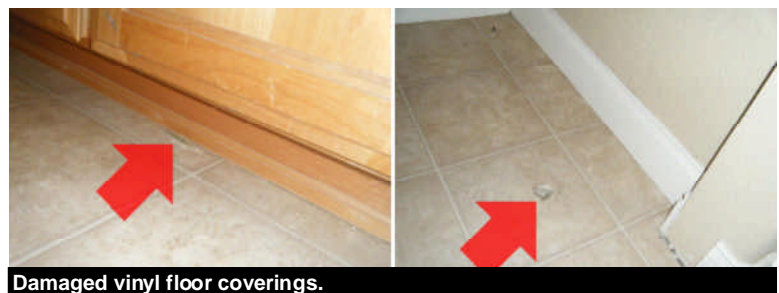
Damaged vinyl floor coverings.

*Damage noted to the vinyl floor covering at main bathroom and laundry area floors.

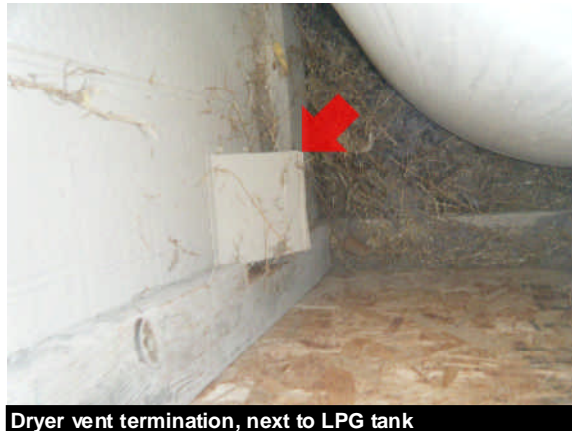
*The dryer vent terminates at poor location. Vent terminates inside of propane tank enclosure, non accessible.

Dryer vent termination, next to LPG tank

Unable to fully view vent. Recommend cleaning of dryer vent. Contact a licensed mechanical / plumbing contractor.
